***THE BRIDGE OF THE VISCONTI FAMILY IN VALEGGIO
SUL MINCIO: FROM PRESERVATION TO MAINTENANCE
FOR A SAFEGUARD STRATEGY***

II. LEVEL MASTER'S THESIS

Giorgia Strabbioli

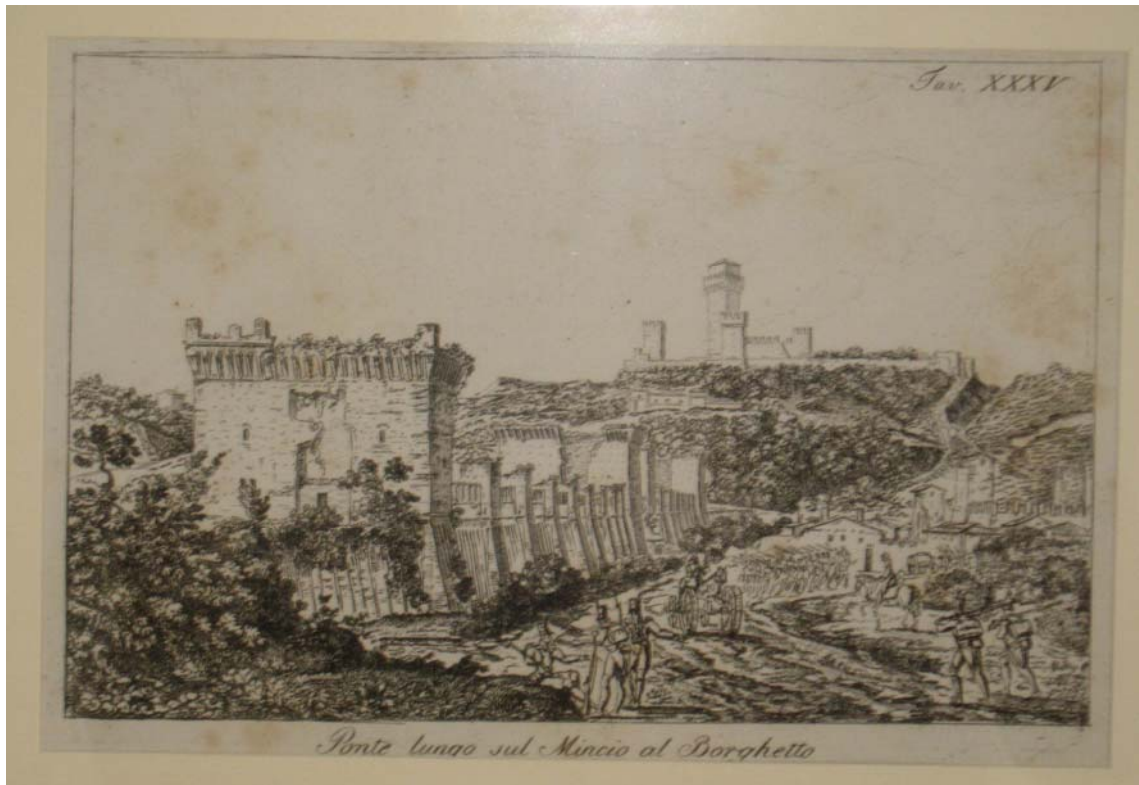
Illustration 1 – « *Ponte lungo sul Mincio al Borghetto* »

Tav. XXXV. Da Persico Giovanbattista. *Descrizione di Verona e della sua Provincia*. Verona, 1820. Private collection.

At this point of historiography, even if no archive documents report any news relevant to the preservation conditions of the bridge, simple deductions on the ancient

wall conditions can be done by observing two historical images (shown above) of the monument.

In the period between 1820/1901, the bridge seems to have suffered from other damages which mainly affect the West front of the Castellana Tower.

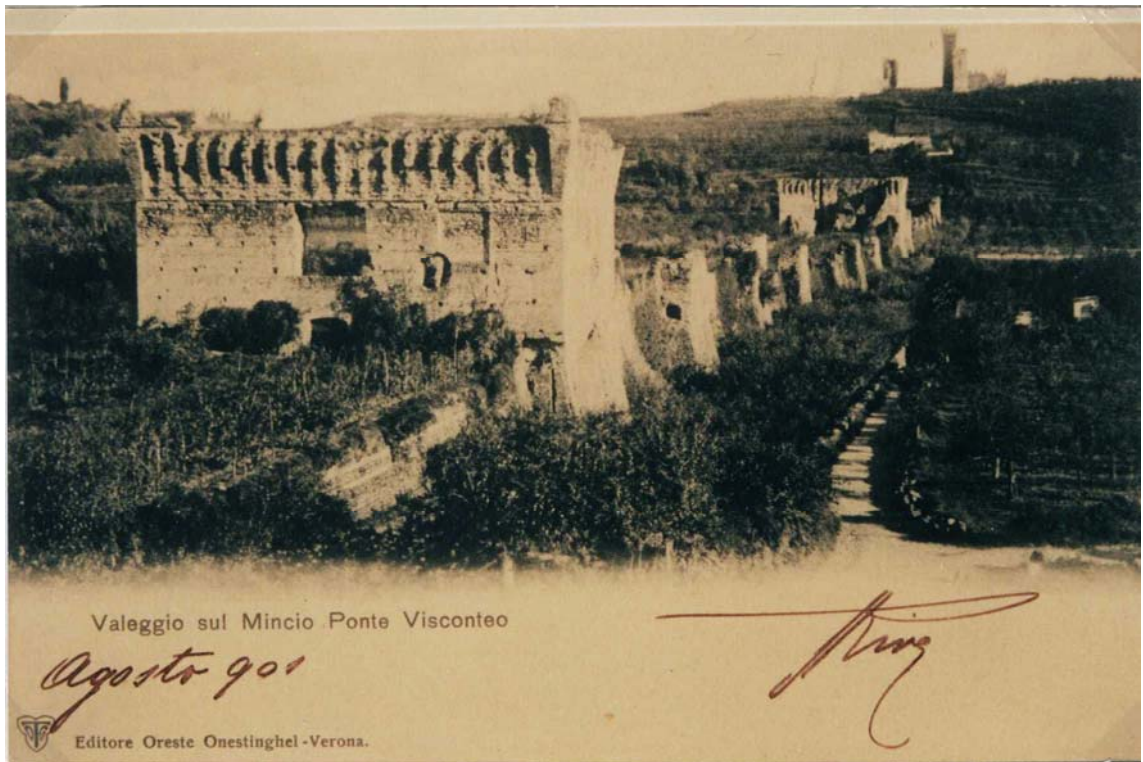
Illustration 2 - Old postcard reproduction

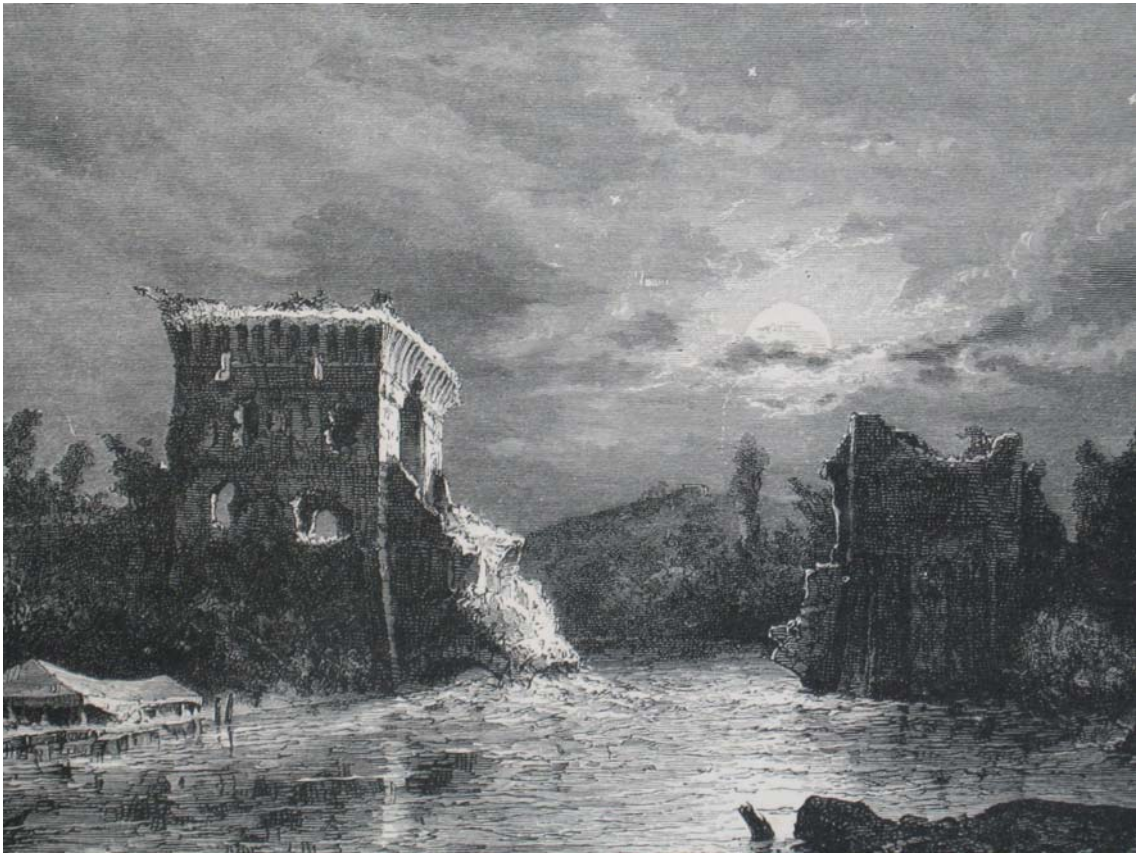
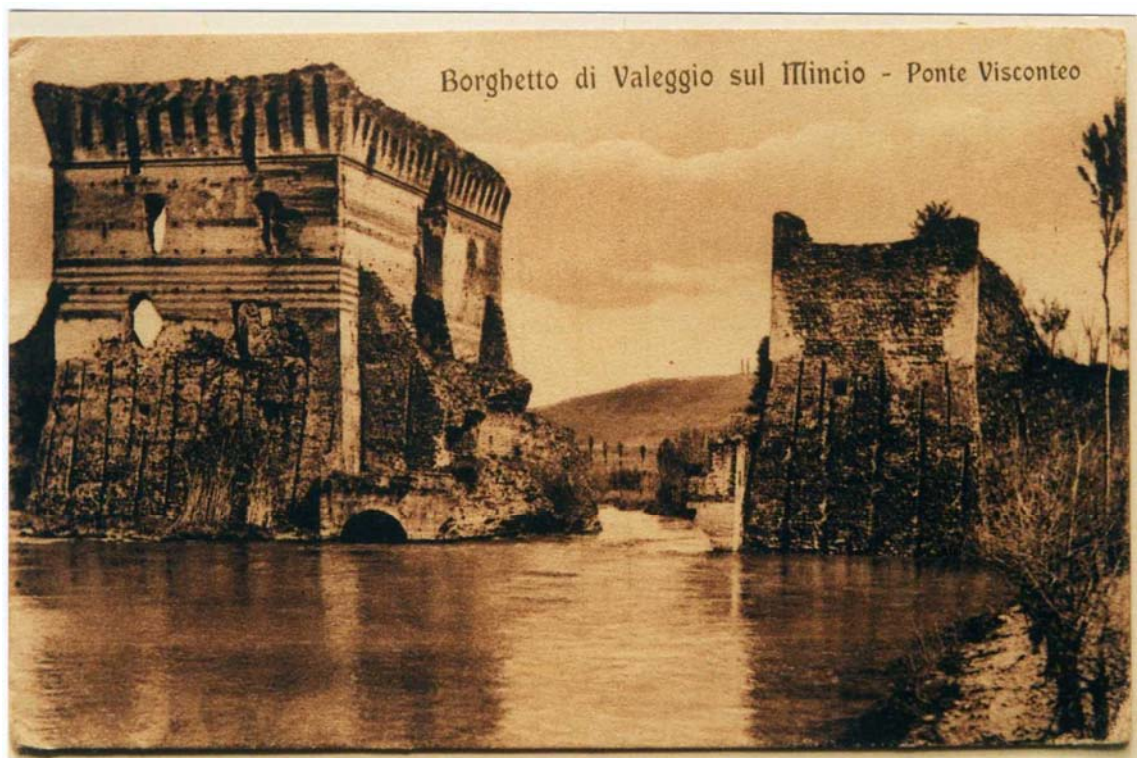
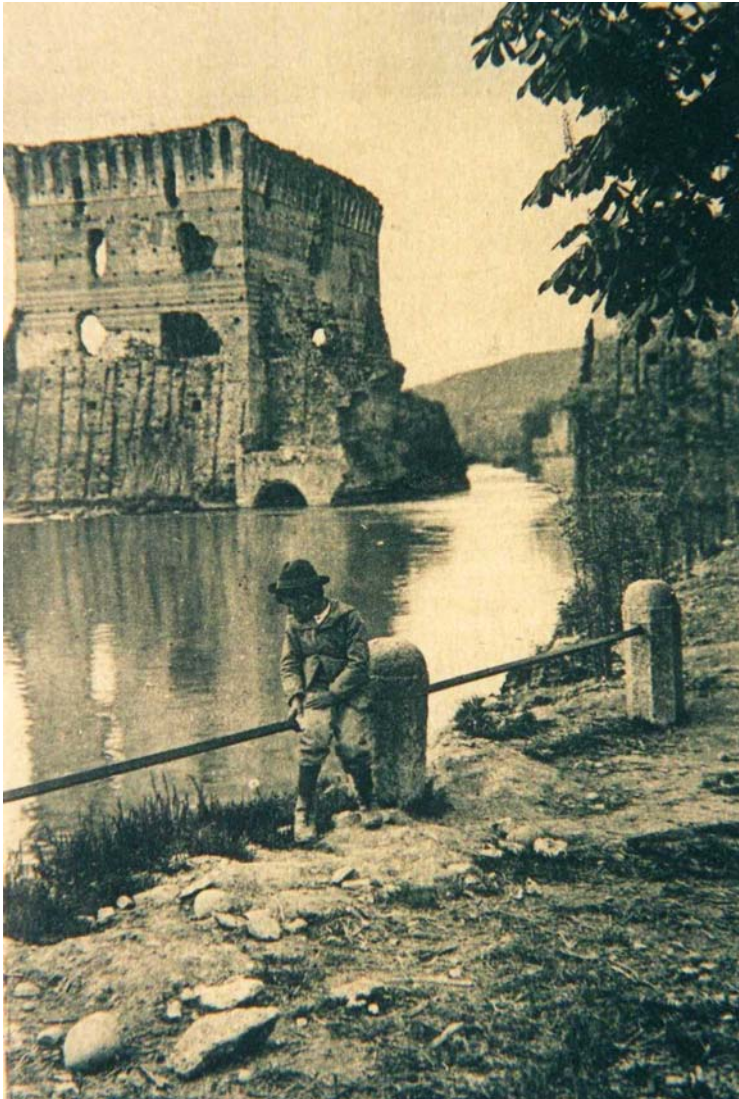
Illustration 4 - « *Bridge of Borghetto, near Valeggio* »

Illustration 5 – Old postcard reproduction

Illustration 6 – Old postcard reproduction

In three documents of the period, a xylograph of 1876 (Ill. 4) and two postcard reproductions, dating back to the first years of the last century (Ill. 5-6), still show the Visconti Bridge interrupted in the central part, but the deep crack that has been marking the wall below the metal girder for several decades is not yet visible.

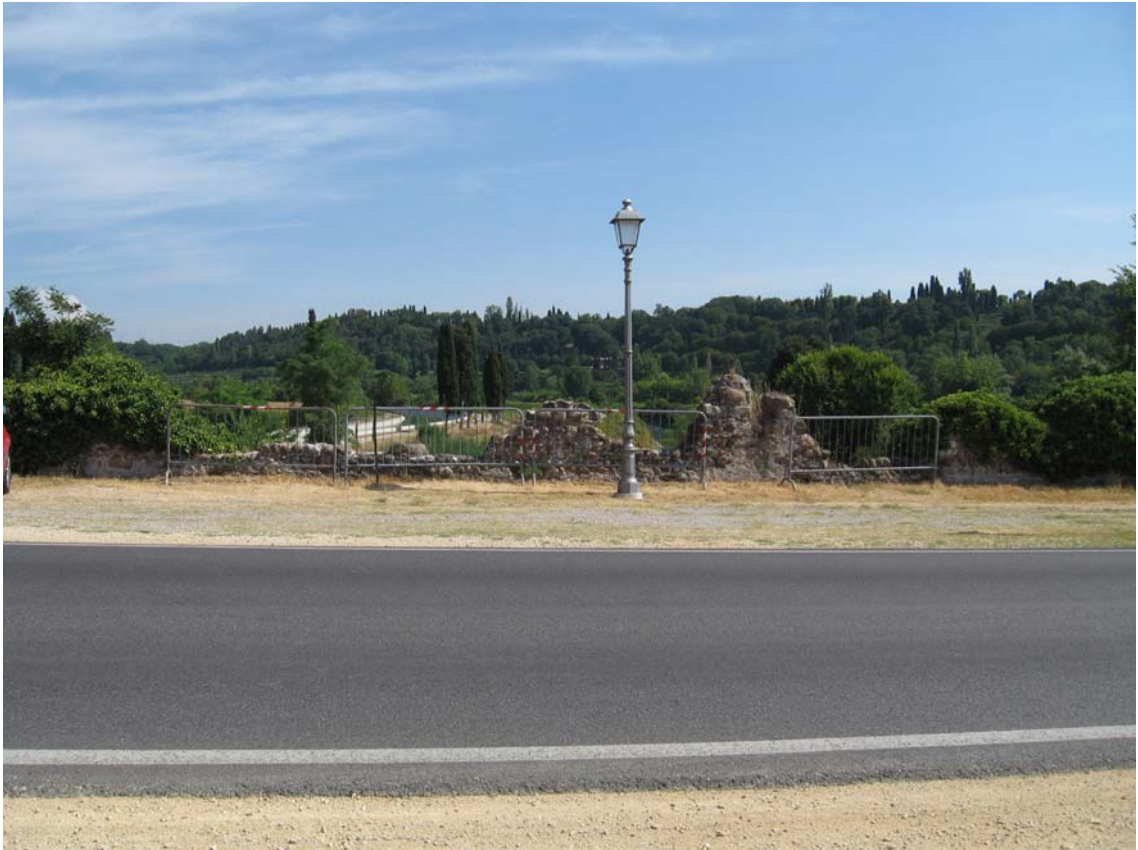
Illustration 10 - The progressive disappearance of the ancient remains of the Bridge

The alarming result is the progressive disappearance of the ancient remains of the Bridge (Ill. 10) and the consequent weakening of the structure.

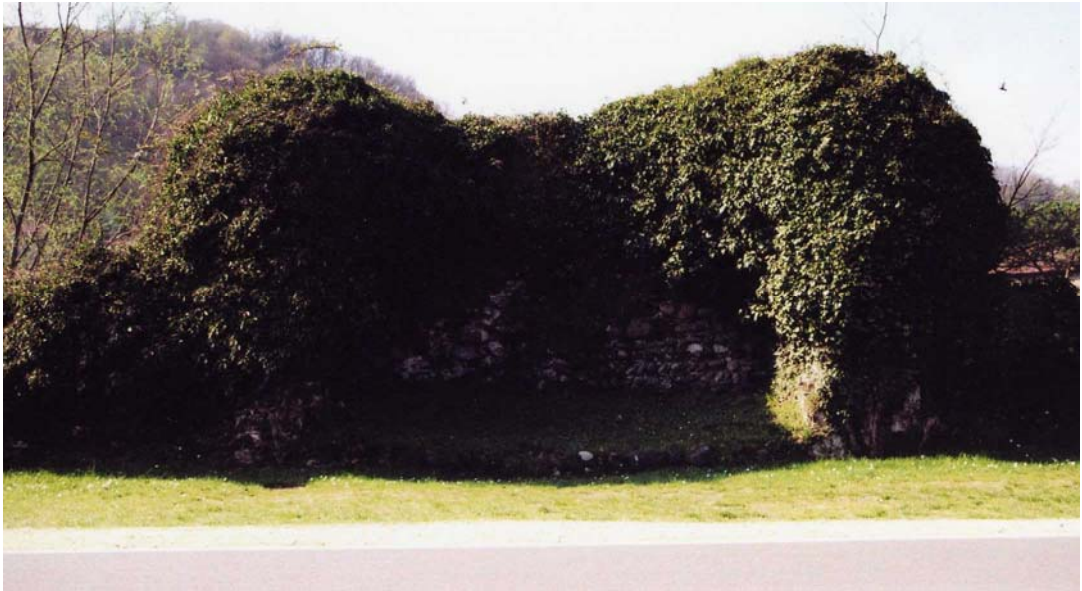
Illustration 11 - Thick vegetation that covers a large part of the Bridge

These problems are exacerbated by thick vegetation that covers a large part of the Bridge and worsens the status of preservation (Ill. 11). Oddly, in a few cases, vegetation seems to maintain the architectonic shapes of the fortification that are mostly lost along the long walls (Ill. 12): tangled vegetation seems the only linking element of the wall face (Ill. 13).

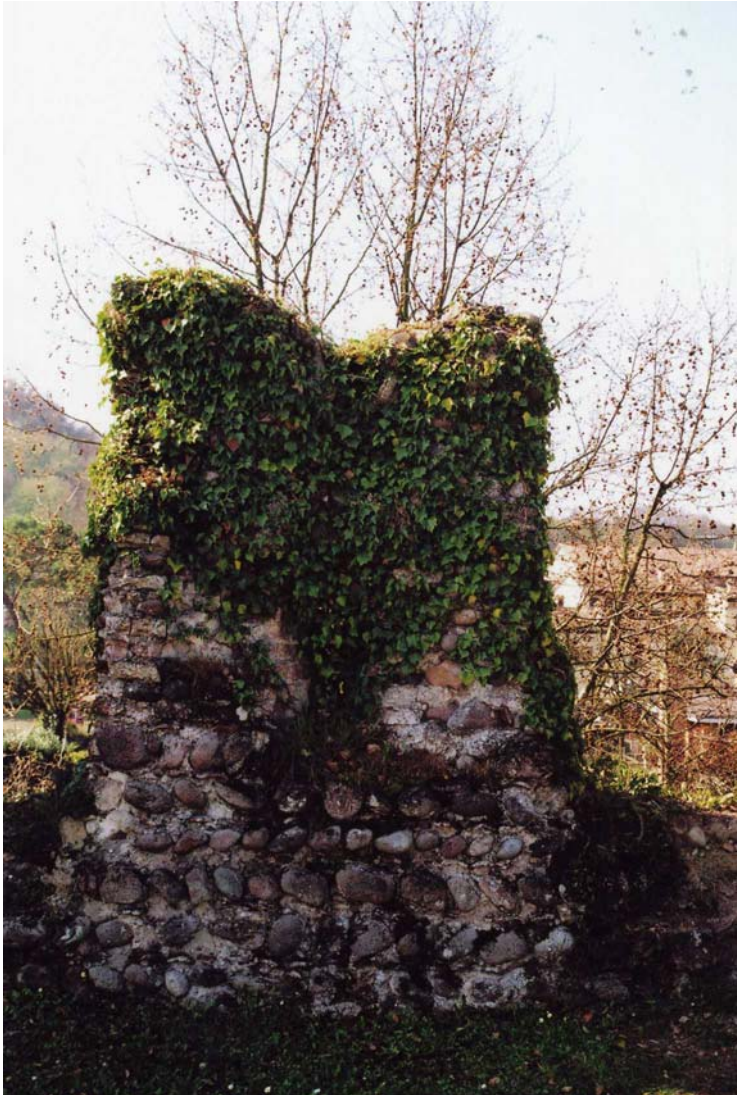
Illustration 12 – The vegetation seems to maintain the architectonic shapes of the fortification

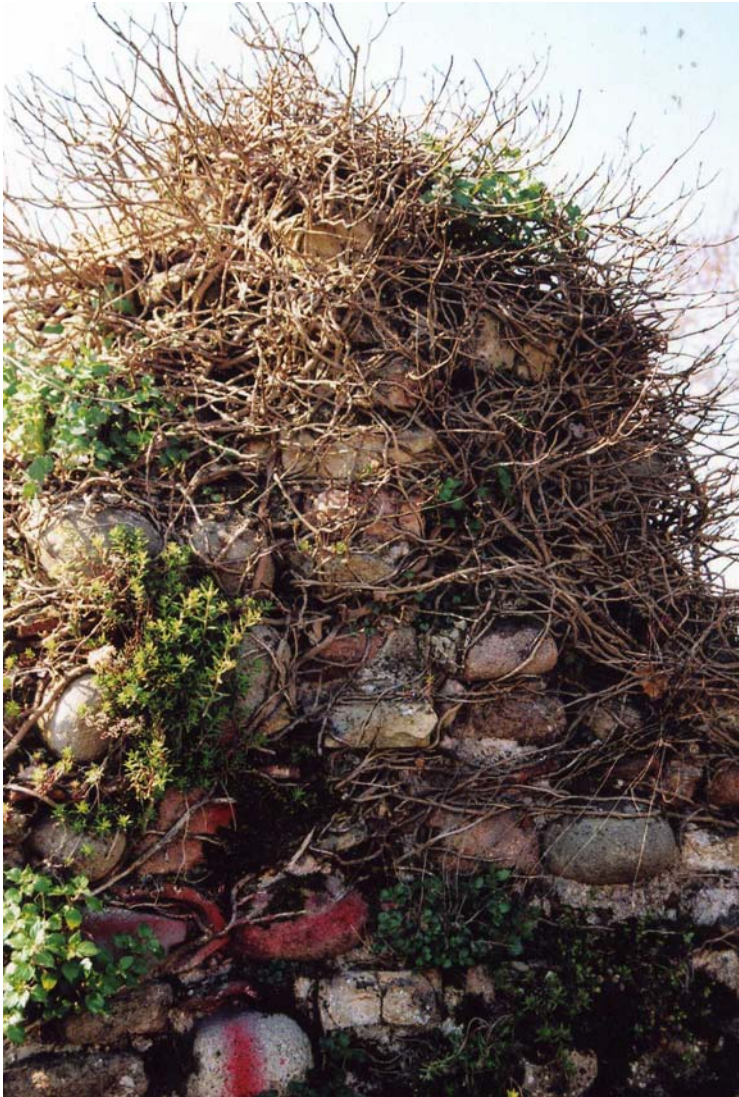
Illustration 13 – The vegetation as the only linking element of the wall face

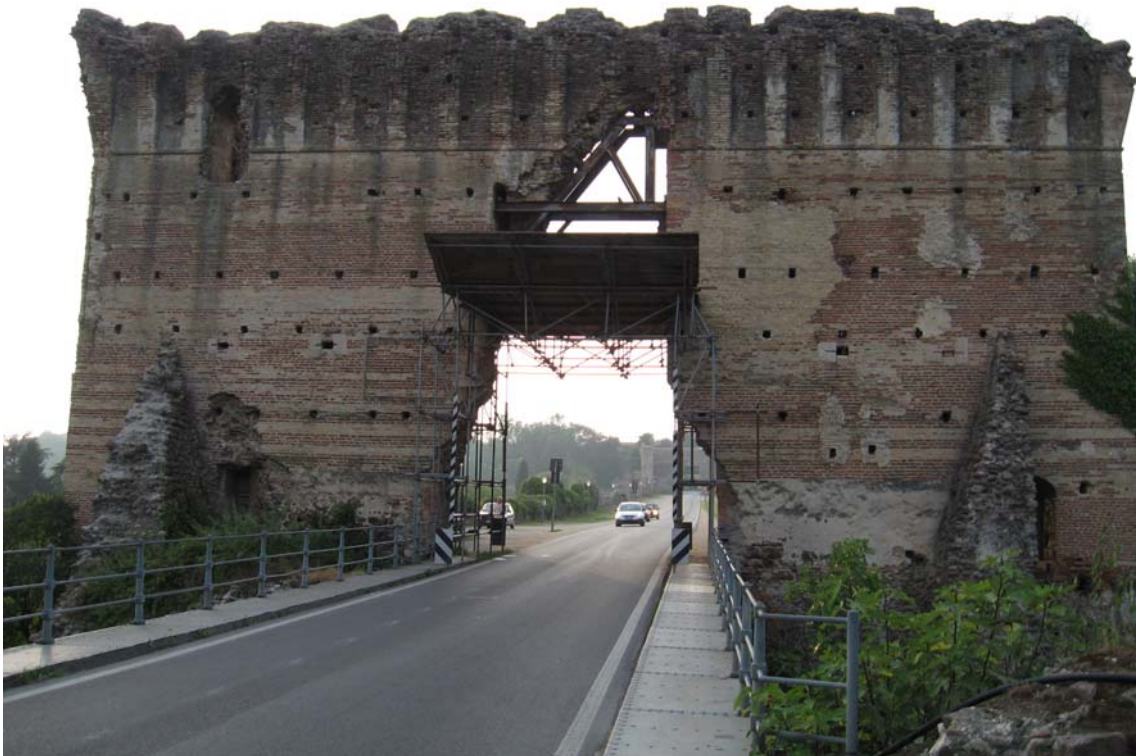
Illustration 14 - Alternating rows of red and yellow bricks on the Castellana Tower

In the specific case of the Castellana Tower, this material was used in a particular way by alternating rows of red and yellow bricks (Ill. 14).

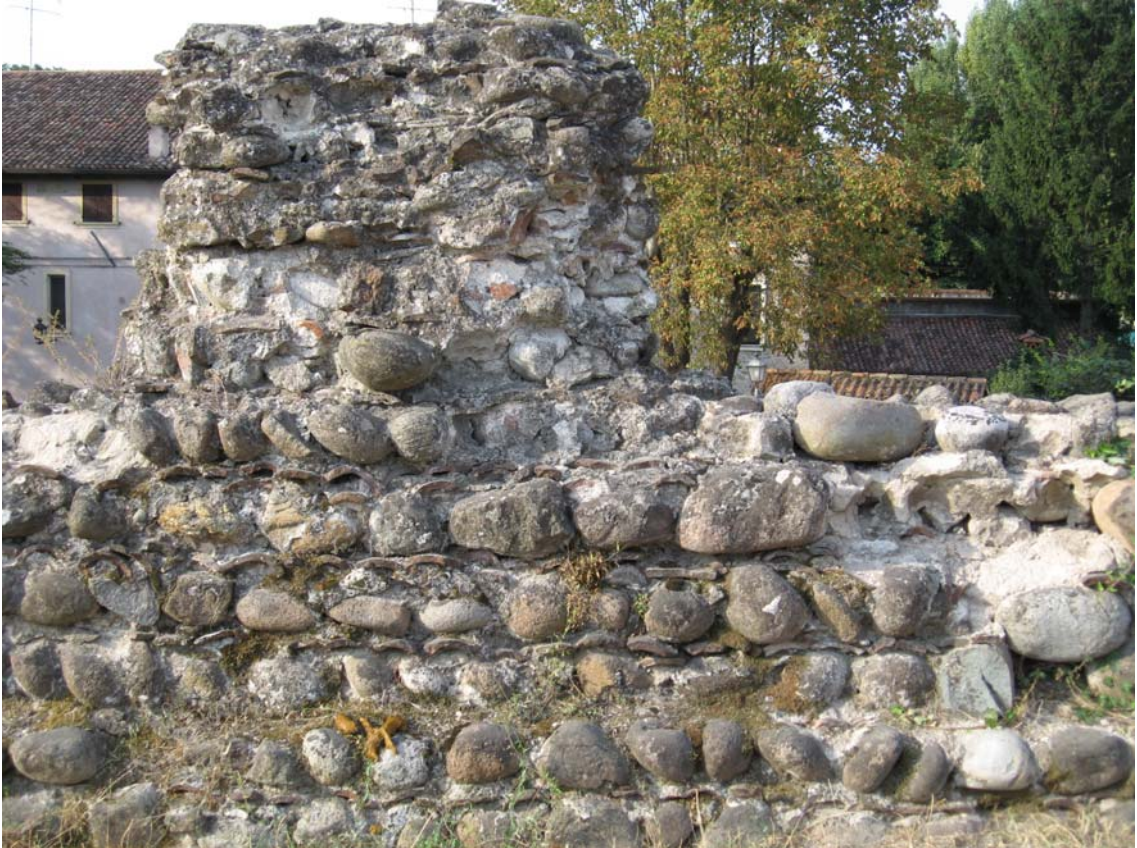
Pathology	Crumbling
Description	General state of a lack of cohesion of stones on the entire rising structure

Illustration 16 – Ancient masonry: sample “A”

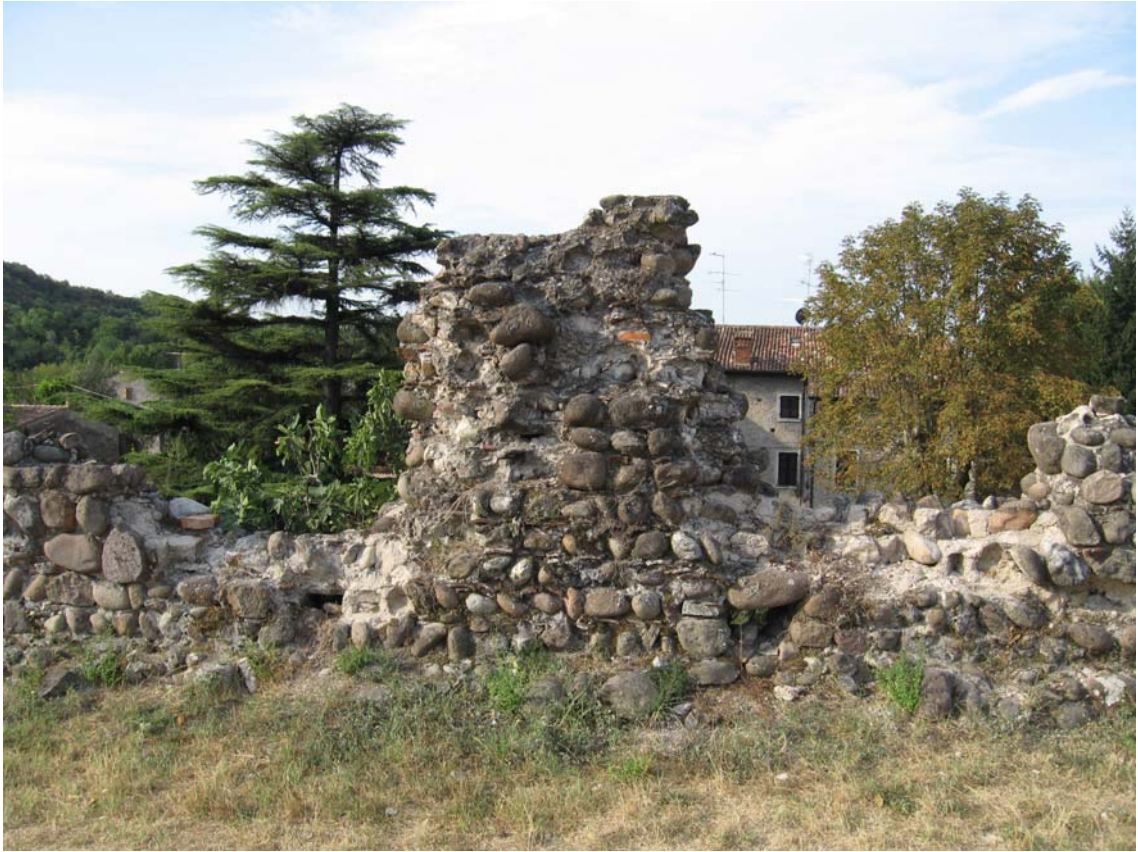
Pathology	Crumbling
Description	General state of a lack of cohesion of stones on the entire rising structure

Illustration 18 – Ancient masonry: sample B

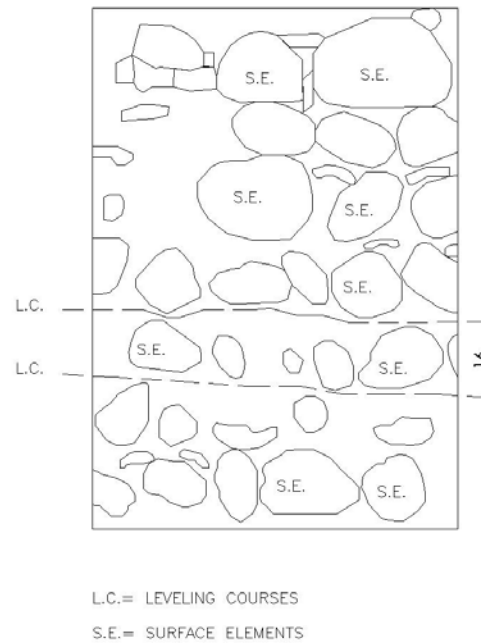
Illustration 19 – Scheme of the part of wall parameter – sample “B”

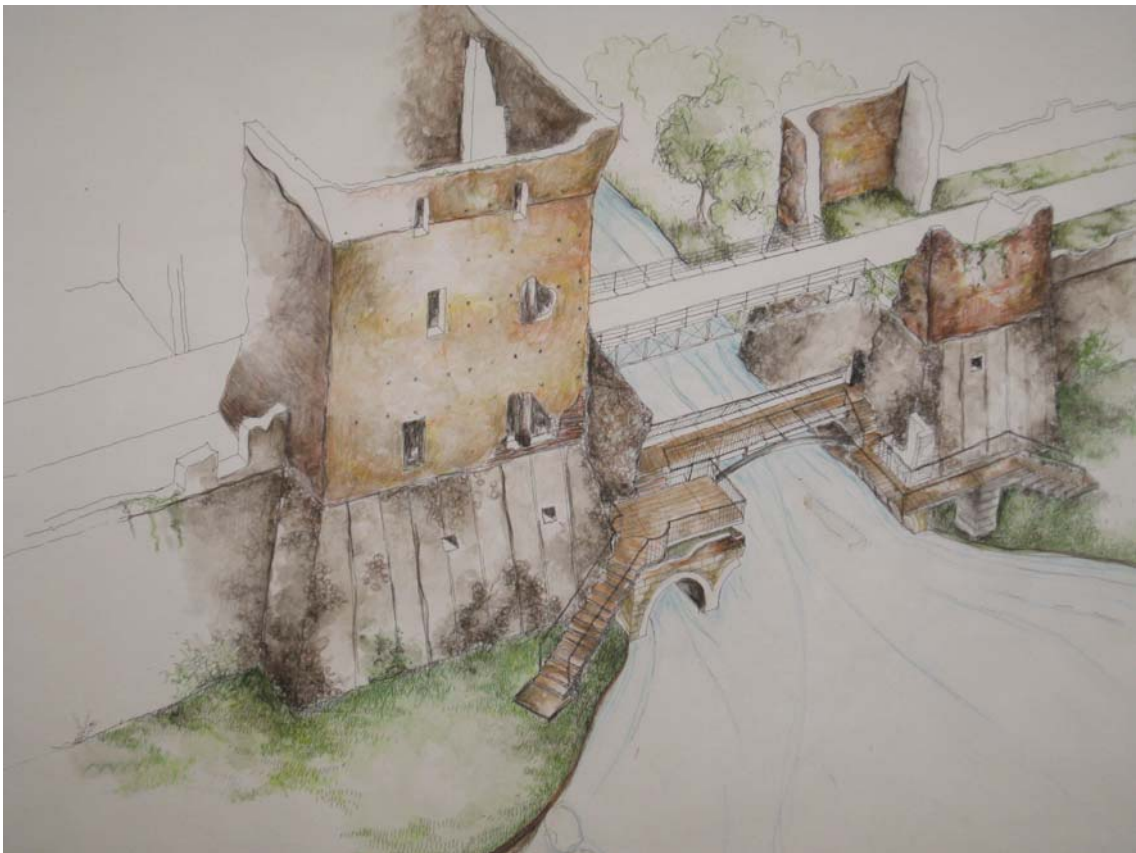
Illustration 20 – The project of functional recovery of the bridge

At the time of the study, the connection of the supporting part to the pedestrian bridge was inserted in the existing wall and had a function of stabilizing the damaged part; therefore, this aspect of the project was not analyzed thoroughly.

Nowadays, this new study, based on the recent anti-seismic regulations relevant to safety standards, evaluates the vulnerability of the building as concerns its restoration and its functional recovery to complete the project path that was started ten years ago.
